Quarterly Report on Monitoring of ICT Infrastructure and Communication Cable Layout

Bhutan InfoComm and Media Authority

(January - March , 2024)

Monitoring of communication cable layout and FTTH network in Tsirang and Dagana

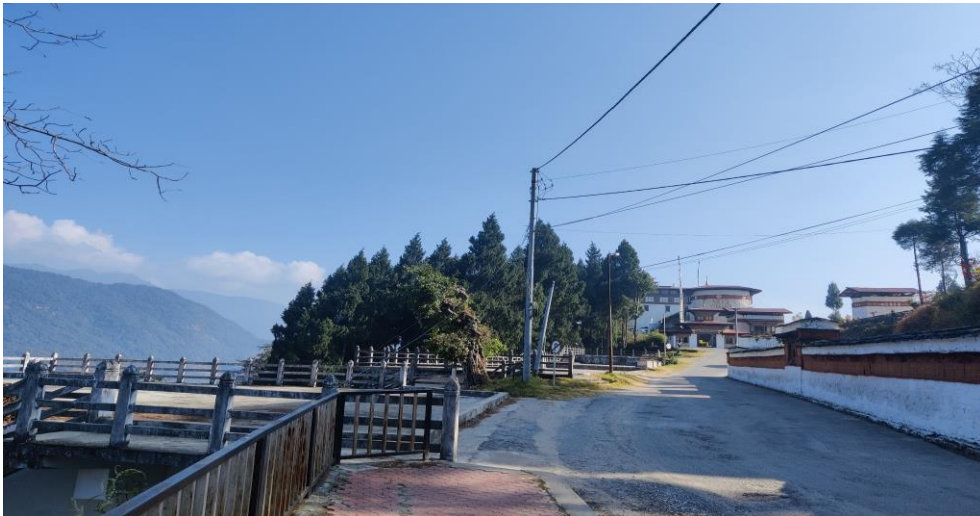
1. Low hanging cables of T&T cable in roads towards Dagana Dzong area from Dagana town

Figure 1: Low hanging cables of T&T cable near Dagana Dzong area

- It is recommended that we may inform and coordinate with relevant stakeholders on the infrastructure sharing and cable layout carried out in above mentioned places.
- May inform service providers to improve their cable layout in other locations wherever required
- To carry out the same monitoring in other thromdes, dzongkhag towns and its peripheral areas.

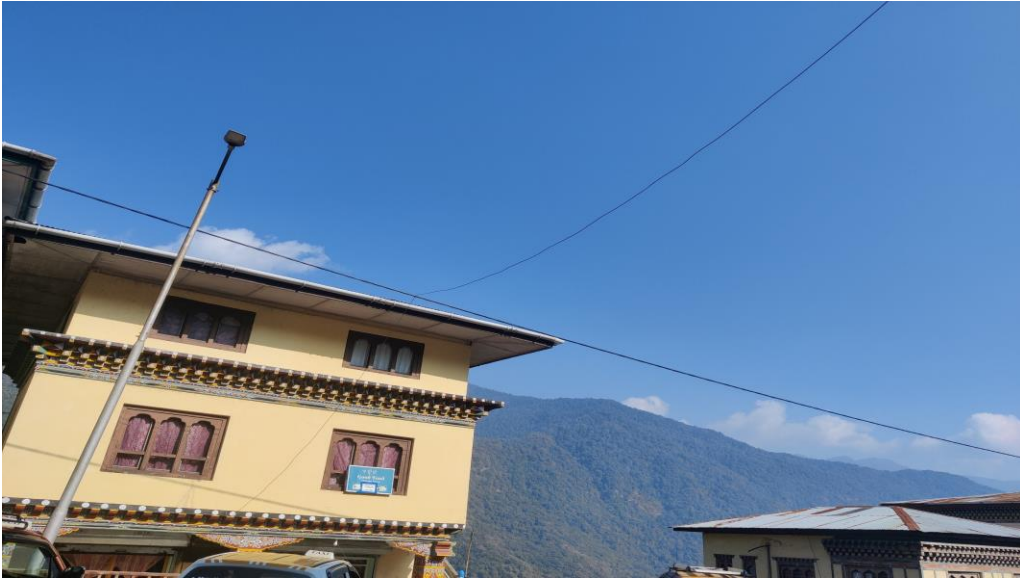
2. Low hanging cable road crossover of T&T cable in Dagana town

Figure 2: Low hanging cross over cable of T & T cable in Dagana town

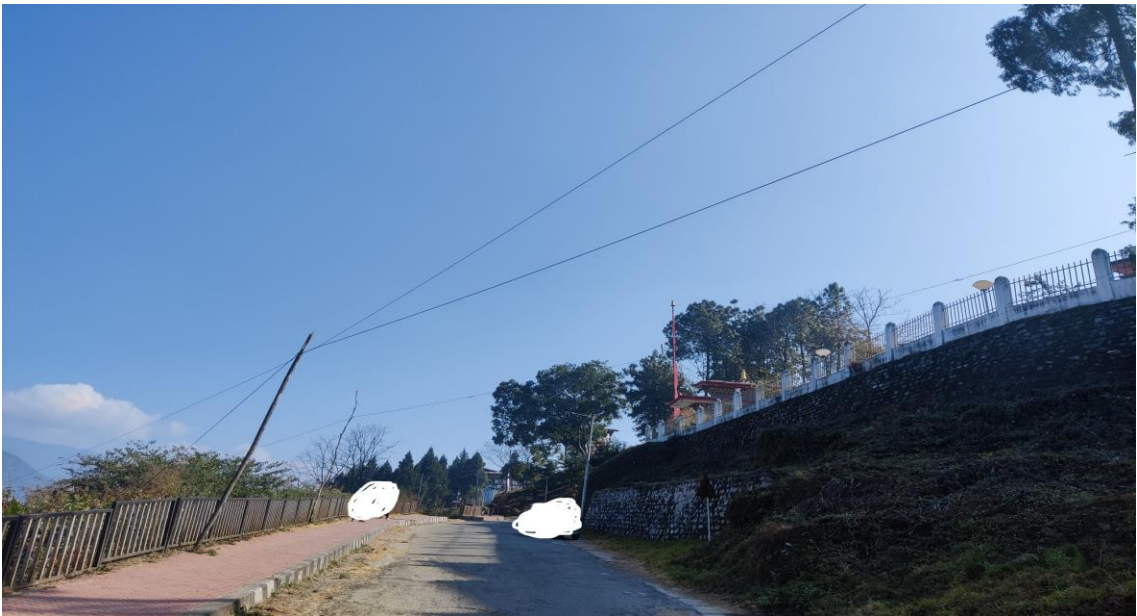
3. Non usage of Poles for cable road crossover despite poles available for sharing by BTL and T&T cable near Dagana Dzong area.

Figure 3 : Non usage of Poles for cable road crossover despite poles available for sharing by BTL and T&T cable near Dagana Dzong area

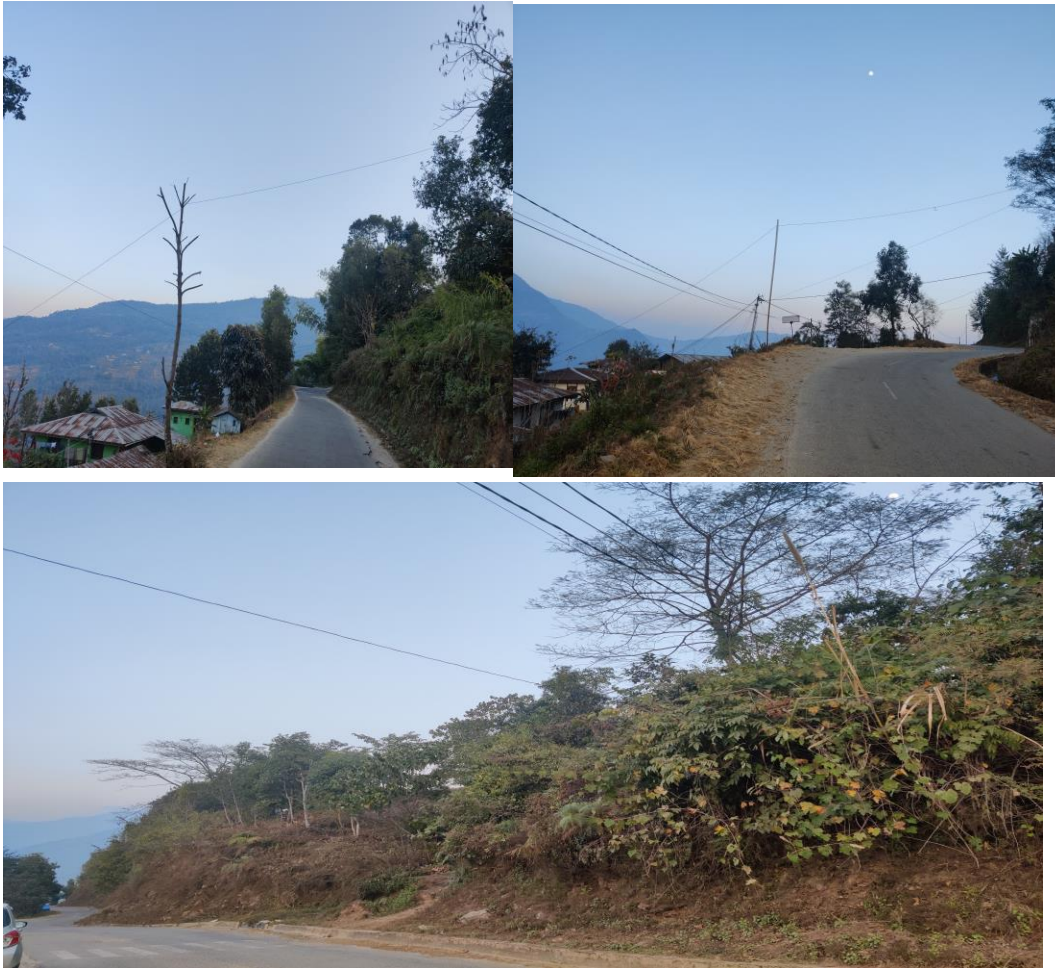
1. Non usage of common poles for cable road cross over in peripheral area of Dagapela town by BTL and NL cable services

Figure 4: Non usage of common poles for cable road cross over in peripheral area of Dagapela town

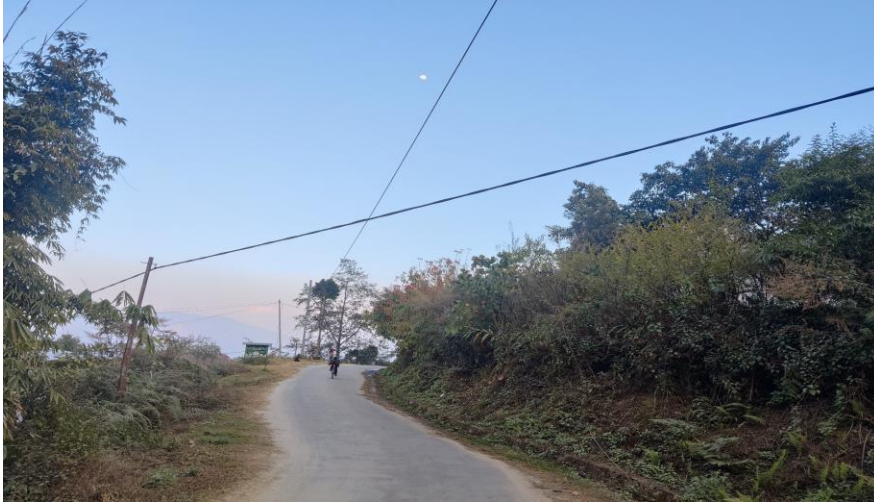
2. Low cable road cross over of BTL in Dagapela Town

Figure 5: Low cable road cross over of BTL in Dagapela Town

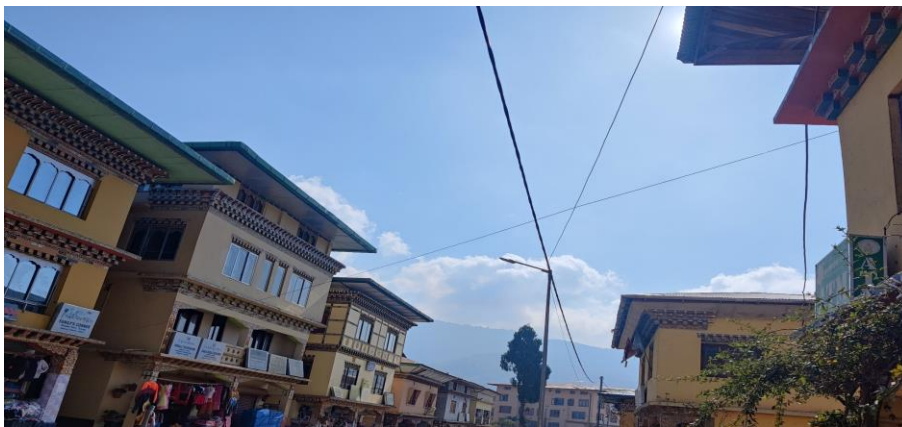
1. Low cable road cross over of Kuenzang cable in Damphu Town, Tsirang

Figure 6: Low cable road cross over of Kuenzang cable in Damphu Town, Tsirang

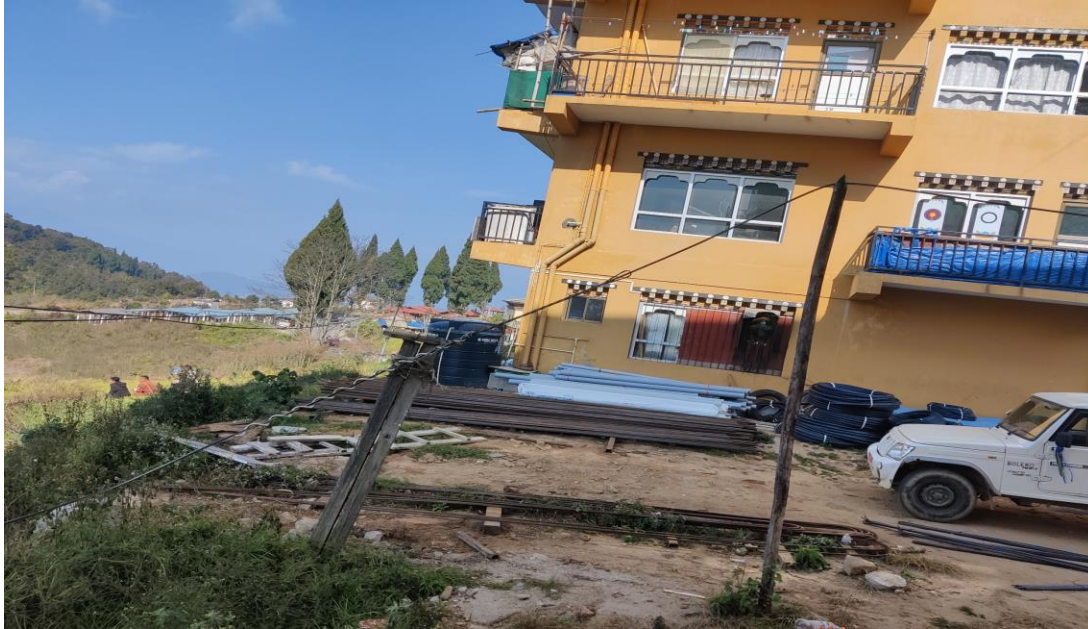
2. Low hanging ADSS fiber cable of Govetch in Damphu Town

Figure 7: Low hanging ADSS fiber cable of Govetch in Damphu Town ,Tsirang

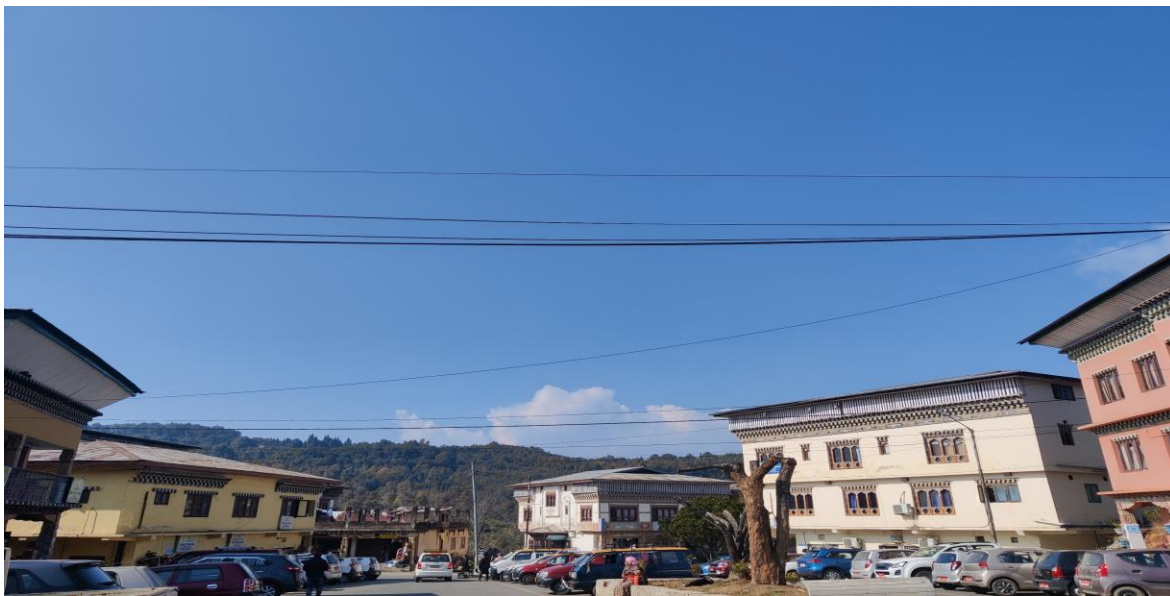
3. Multiple cable road cross over of BTL and Kuenzang cable in Damphu town, Tsirang

Figure 8: Multiple cable road cross over of BTL and Kuenzang cable in Damphu town, Tsirang

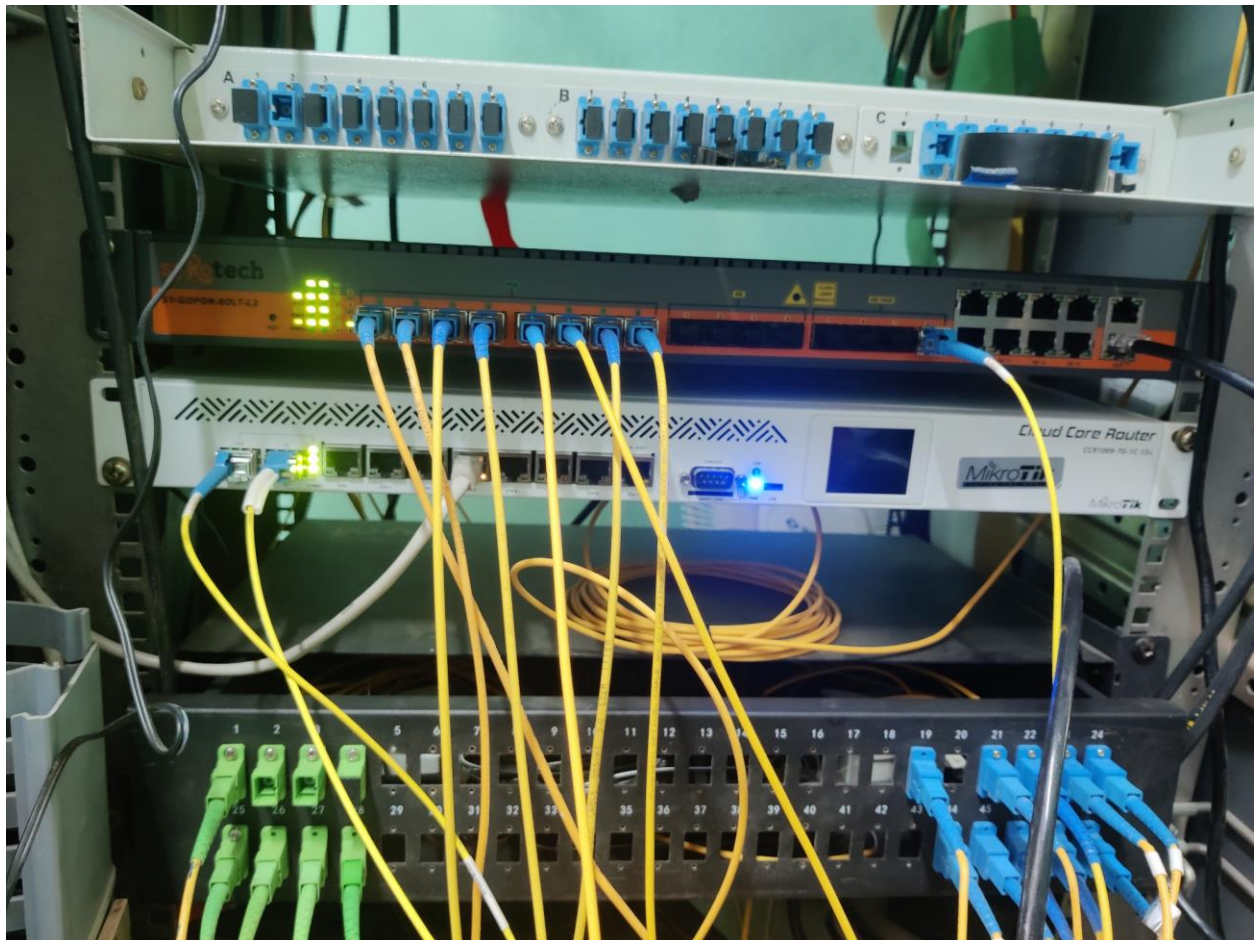
The Kuenzang cable service has deployed SyRO tech GPON 8- OLT FTTH equipment for internet distribution in Damphu town and its peripheral area. The GPON equipment has 8 ports and each port has the capacity to distribute to 16 customers.

Figure 9: CyRO tech GPON 8-OLT equipment installed at Kuenzang cable network center,Damphu town.

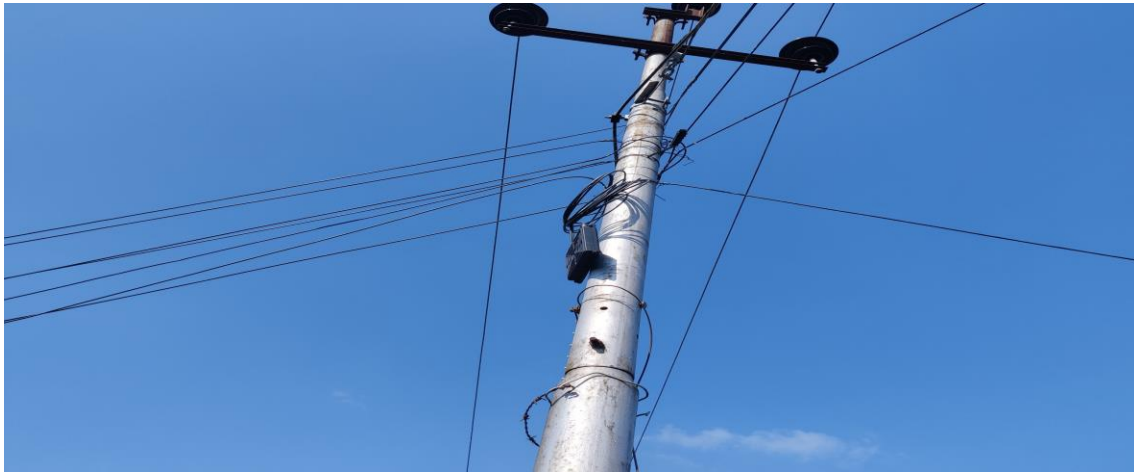
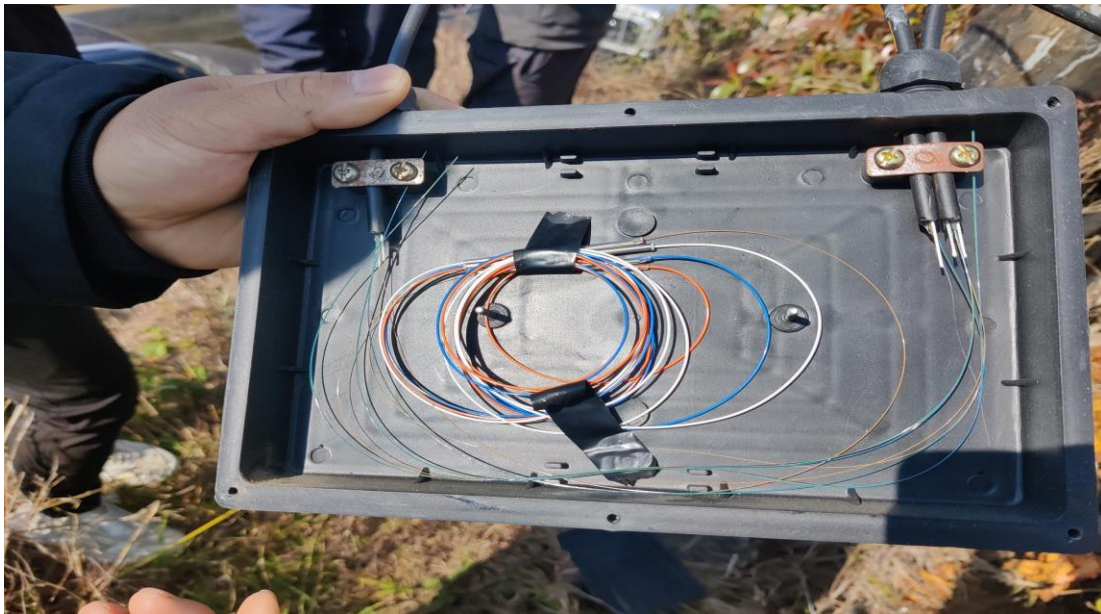
2. The FTTH network splitters deployed near Damphu Town for internet leased line distribution in Damphu town and peripheral areas.

Figure 10: The FTTH network splitters deployed near Damphu Town
